Surface Properties and Fatigue Resistance of AM-Structures

R. Heuberger, A. Butscher

RMS Foundation, Bettlach, CH

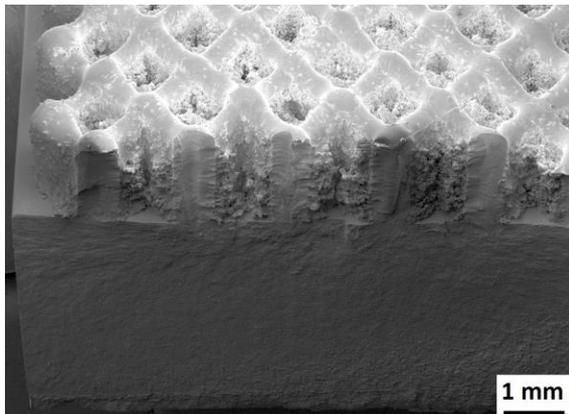
There was an early failure of the bars with the AM-structures in the 4-point bending test (< 300'000 cycles at 270 MPa vs. > 700'000 cycles at 600 MPa for Ti-bars w/o structure). The SEM-investigation showed multiple crack initiation within the AM-structure (Figs. 1 & 2).

Fig. 1: SEM-image of the fracture surface. The AM-structure was deposited on a bar by laser metal deposition.

DISCUSSION & CONCLUSIONS: The reason for the failure was the higher hardness due to a higher oxygen content of the AM-structures compared to the bulk material. Thus the upper part was more brittle than the bulk. This led to cracks in the AM-structure and at the interface, and finally to the early failure of the components due to the cyclic bending stress and notch sensitivity.

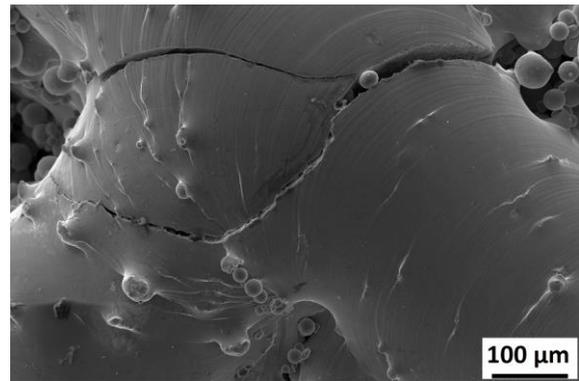
Fig. 2: SEM-image of the AM-structure with secondary cracks.

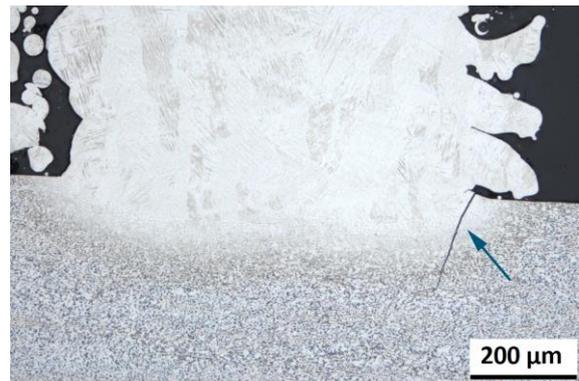
The metallographic examination of the broken samples showed additional secondary cracks that start at the interface (Fig. 3). The microstructure of the AM-structure and of the heat affected zone at the interface was dendritic, while the bar exhibited small grains. The AM-structures were harder than the bulk (389 ± 2 vs. 322 ± 10 HV_{0.5}). This was related to a higher oxygen content in the AM-structure.

Fig. 3: Optical image of an etched cross-section to reveal the grain structure. The arrow points on a secondary crack at the interface.
