SURFACE PROPERTIES AND FATIGUE RESISTANCE OF AM-STRUCTURES

R. Heuberger*, A. Butscher, both RMS Foundation, Bettlach, CH
 *roman.heuberger@rms-foundation.ch, +41 32 644 20 22

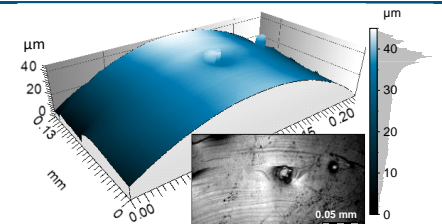
- Overspray
- Small metallic droplets
- Roughness Ra of the structures ranged from 0.11 to 1.2 μm

Topography measured with confocal microscopy

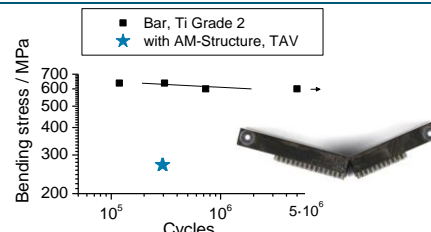
There was an early failure of the bars with the AM-structures in the 4-point bending test!

The SEM-investigation showed that there was a multiple crack initiation within the AM-structure.

Early fracture of the bars with AM-structures

The reason for the failure was the higher hardness due to the dendritic grains and a higher oxygen content of the AM-structures compared to the bulk material. Thus, the upper part was more brittle than the bulk. This led to cracks in the AM-structure and at the interface, and finally to the early failure of the components due to the cyclic bending stress and notch sensitivity.
